INDOOR AIR QUALITY ASSESSMENT

**Massachusetts Department of Education
Bureau of Special Education Appeals
11 Dartmouth Street
Malden, Massachusetts**

Prepared by:
Massachusetts Department of Public Health
Center for Environmental Health
Emergency Response/Indoor Air Quality Program
March 2006

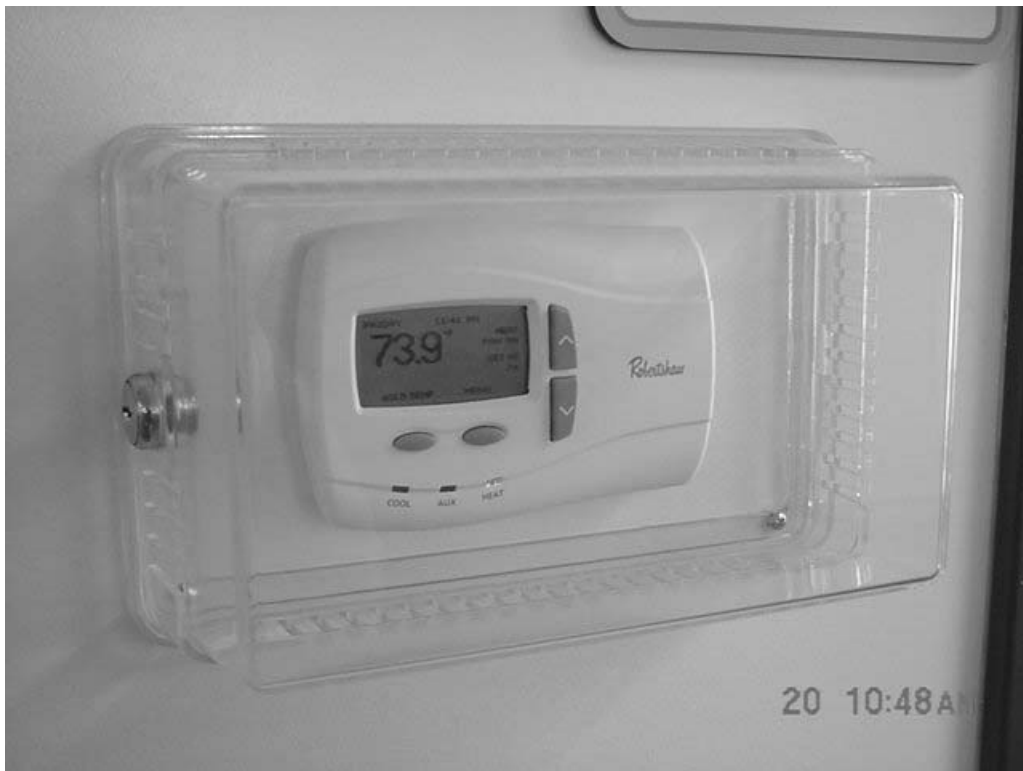
Picture 1

Thermostats that control the HVAC system have fan settings of “on” and “automatic”. Thermostats were set to the fan “on” setting (Picture 1) providing continuous airflow, which is recommended by the MDPH. The “automatic” setting on the thermostat activates the

Thermostat set to Fan “On” Mode

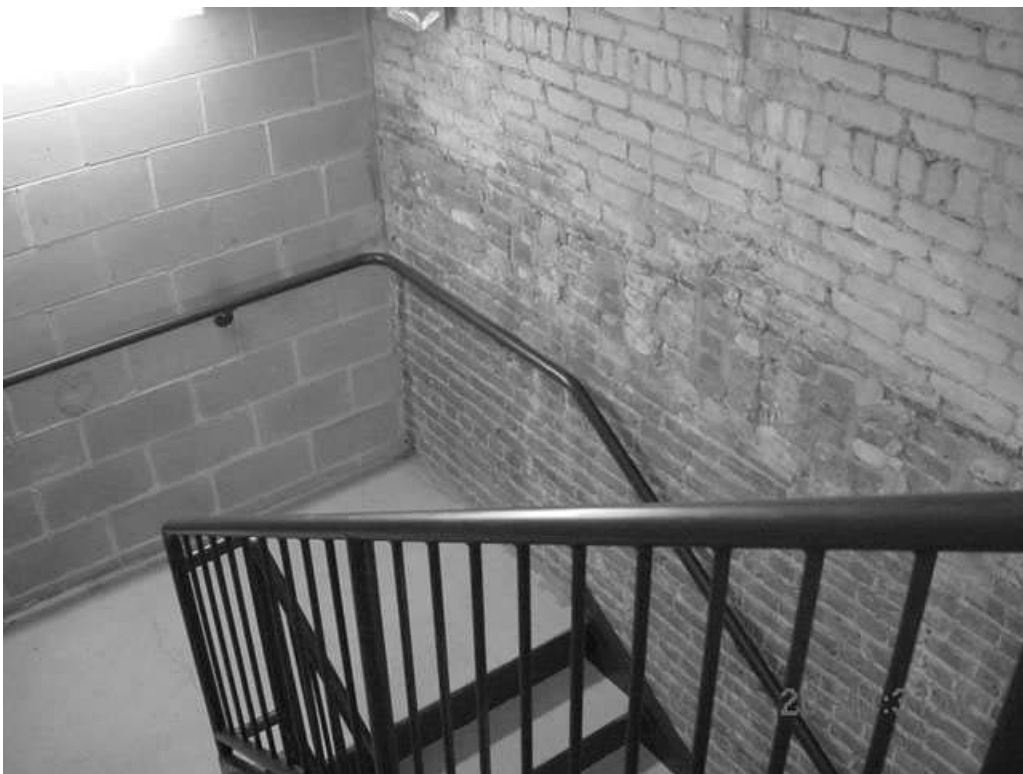
Picture 2

Employees reported concerns over musty/mold like odors in the stairwell. In order for building materials to support mold growth, a source of moisture is necessary, such as roof or plumbing leaks. Identification and elimination of water moistening building materials is necessary to control mold growth. MDPH staff performed a visual examination of the stairwell for signs of water penetration, damage and/or mold growth. All areas appeared dry, and no visible mold growth and/or associated odors were observed/detected on the day of the assessment. It is worth noting, however, that the stairwell consists of unfinished brick/cinder block walls and cement floors that make it prone to dust accumulation (Picture 2). The third floor door to the stairwell had spaces beneath the door where light could be seen penetrating, which can serve as a potential pathway for drafts and dust to migrate into occupied areas (Picture 3).

Unfinished Stairwell

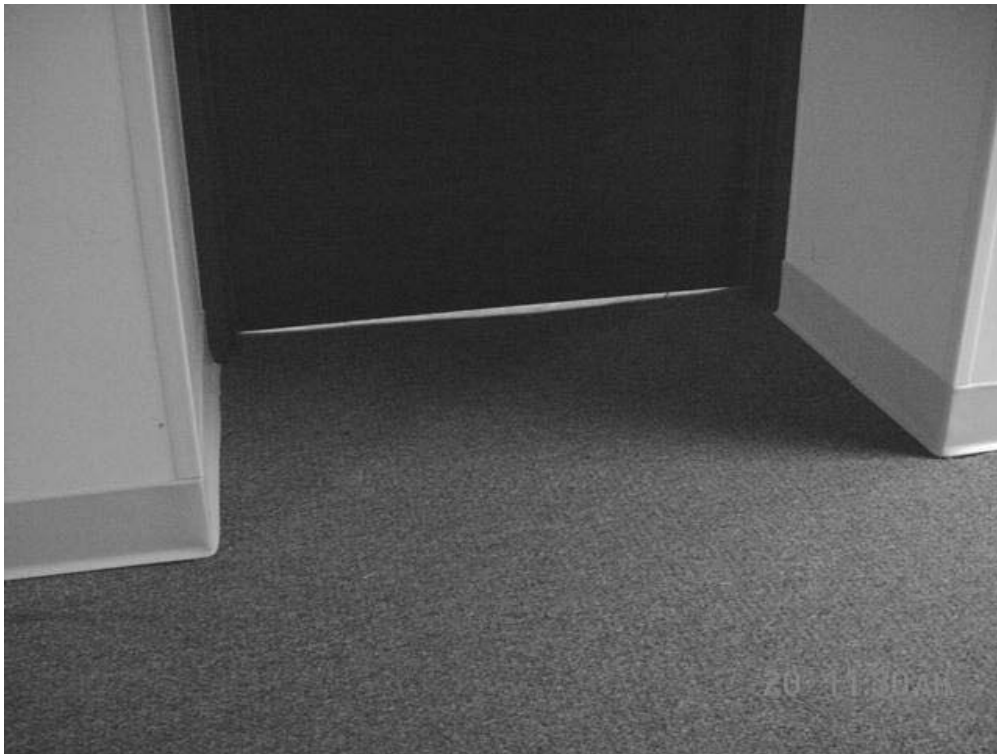
Picture 3

Space under Stairwell Door 2nd Floor

3. Install weather-stripping on bottom of stairwell door on third floor to prevent movement of odors and materials.
4. Ensure plants have drip pans. Examine drip pans periodically for mold growth and disinfect with an appropriate antimicrobial where necessary.

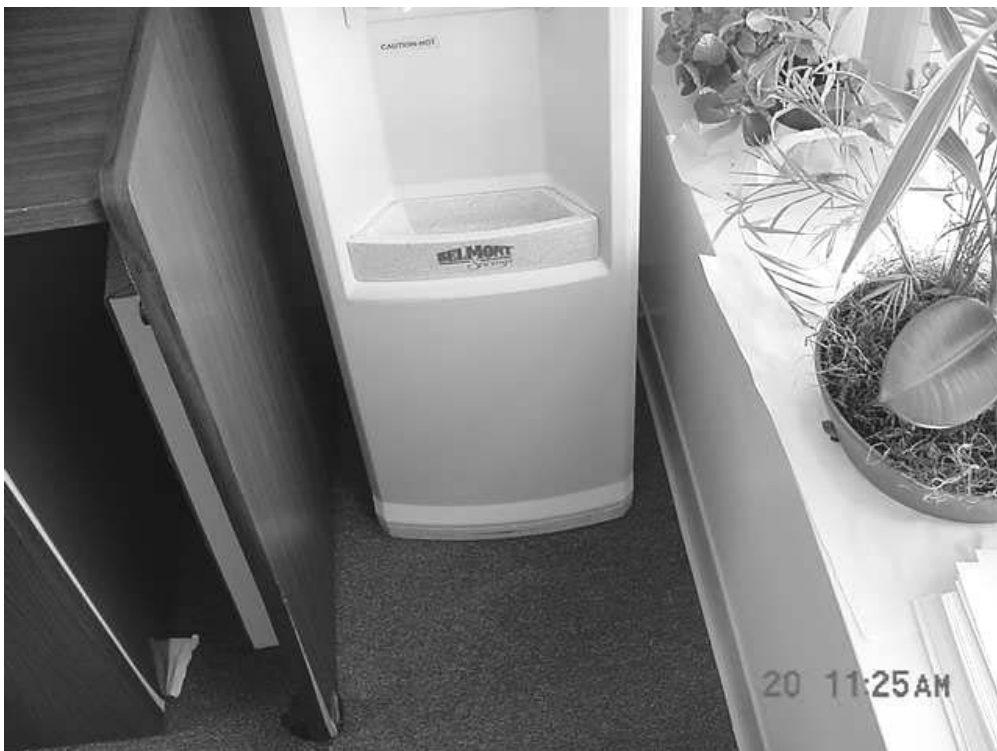
Picture 4

Water coolers were located directly on carpeting (Picture 4). Water spillage or overflow of cooler catch basins can result in the wetting of the carpet. In addition, some of the coolers had residue/build-up in the reservoir. These reservoirs are designed to catch excess water during operation and should be emptied/cleaned regularly to prevent microbial and/or bacterial growth.

Water Cooler on Carpeting

5. Relocate water coolers to non-carpeted areas or place tile or rubber matting underneath water coolers in carpeted areas. Clean and disinfect reservoirs as needed to prevent microbial growth.

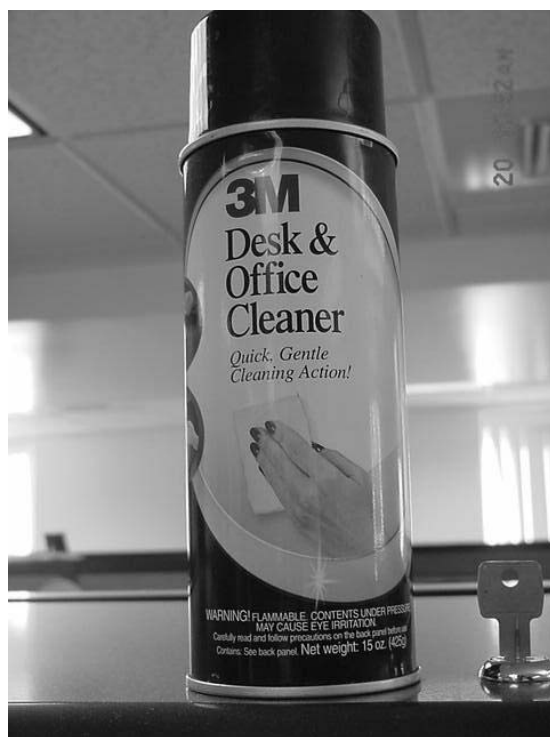
Picture 5

MDPH staff also noted the presence of VOC-containing cleaning materials (Picture 5). VOCs (e.g., isopropyl alcohol and monoethanolamine) can be irritating to the eyes, nose and throat (3M, 2000) (Picture 6). When combined, the presence of dust, low relative humidity,

Spray Office Cleaner

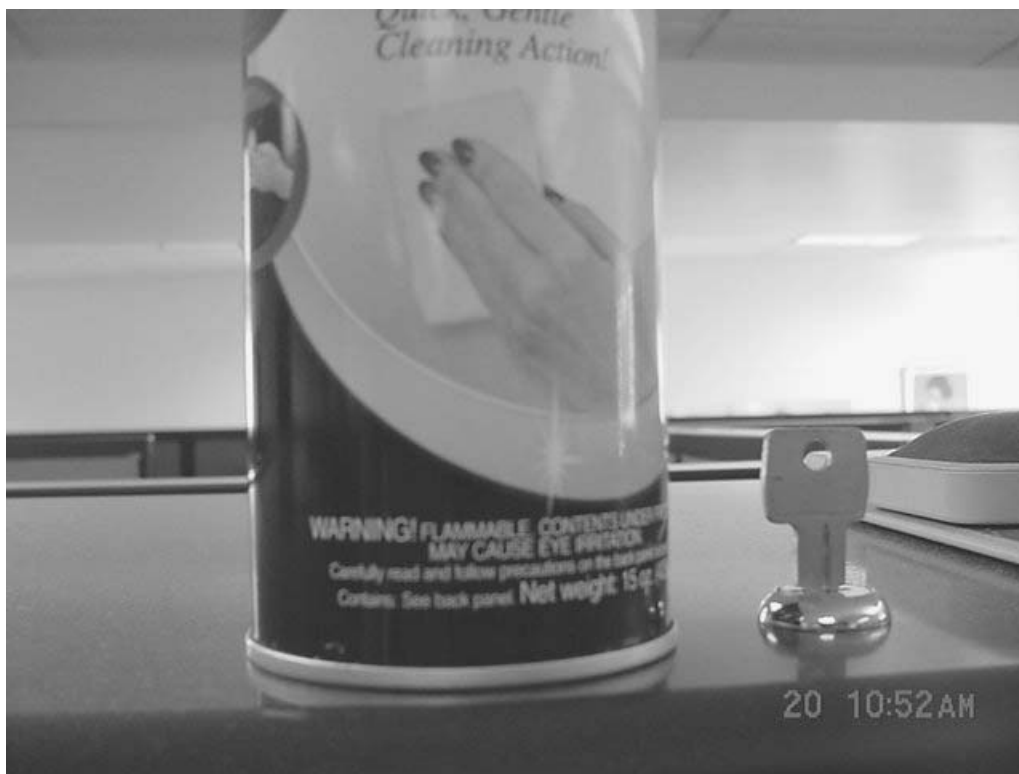
Picture 6

Close up of Label on Spray Office Cleaner: Warning! Flammable Contents May Cause Eye Irritation
